National Dam Inspection Program.

Lower Kittanning Dam (NDI-529),
Susquehanna River Basin, Burgoon
Run, Blair County, Pennsylvania.
Phase I Inspection Report.

PHASE I REPORT
NATIONAL DAM INSPECTION PROGRAM

PHASE I REPORT
NATIONAL DAM INSPECTION PROGRAM
LOWER KITTANNING DAM
NDI I.D. NO. 529
DER I.D. NO. 7-14

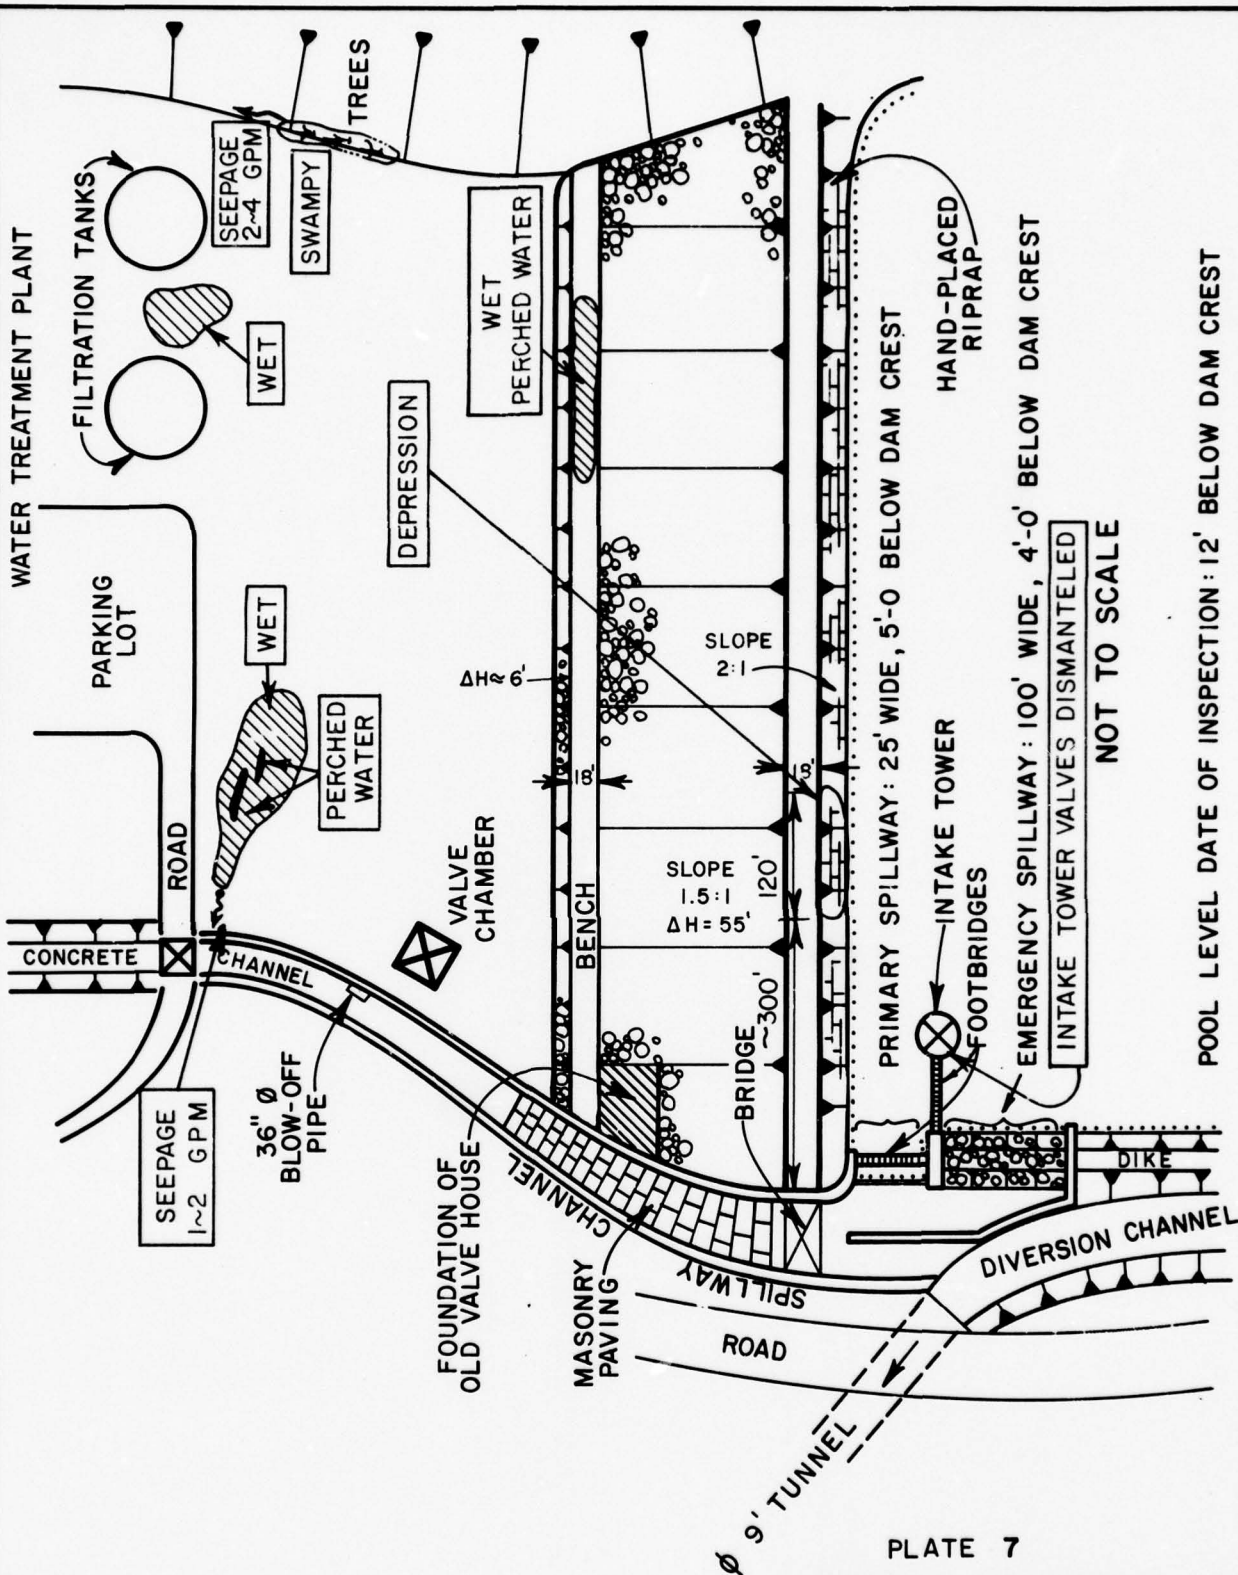
PLATE 7
 LOWER DAM NDI ID: 529
 GENERAL PLAN
 FIELD INSPECTION NOTES
 FIELD INSPECTION DATE: AUGUST 9, 1978

1. A depression was observed on the upstream slope of the dam about 300 feet from the left abutment of the dam (Photographs 9 and 10). Measured vertically, the depression was about 18 inches deep at its left extreme and gradually diminished over a distance of 120 feet toward the right abutment.
2. Four wet areas were found on the downstream side of the dam. The first wet area was located on the bench at the toe of the dam near the right abutment. Water was perched on the bench. No measurable seepage was observed. The other three wet areas were located about 100 feet downstream of the toe of the dam. Plate 7 illustrates the location of these wet areas.

VISUAL EXAMINATION OF	OBSERVATIONS	REMARKS OR RECOMMENDATIONS
JUNCTION OF EMBANKMENT AND ABUTMENT, SPILLWAY AND DAM	NO VISUAL SIGNS OF DISTRESS NO SEEPAGE.	
ANY NOTICEABLE SEEPAGE	SOME MINOR SEEPS BELOW TOE SEE PLATE 7 FOR LOCATION AND SEEPAGE QUANTITY ESTIMATES.	
STAFF GAGE AND RECORDER	NONE	
DRAINS	NONE.

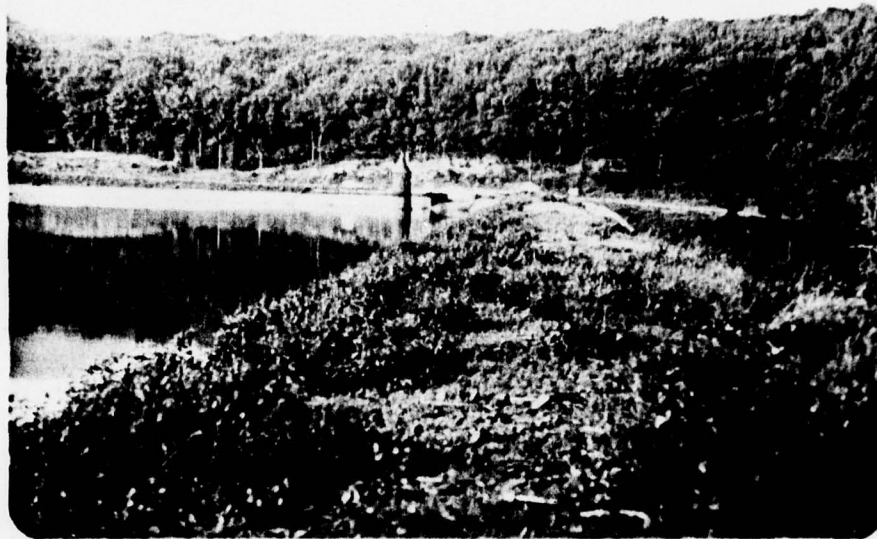
Photograph No. 1
Crest (looking north).

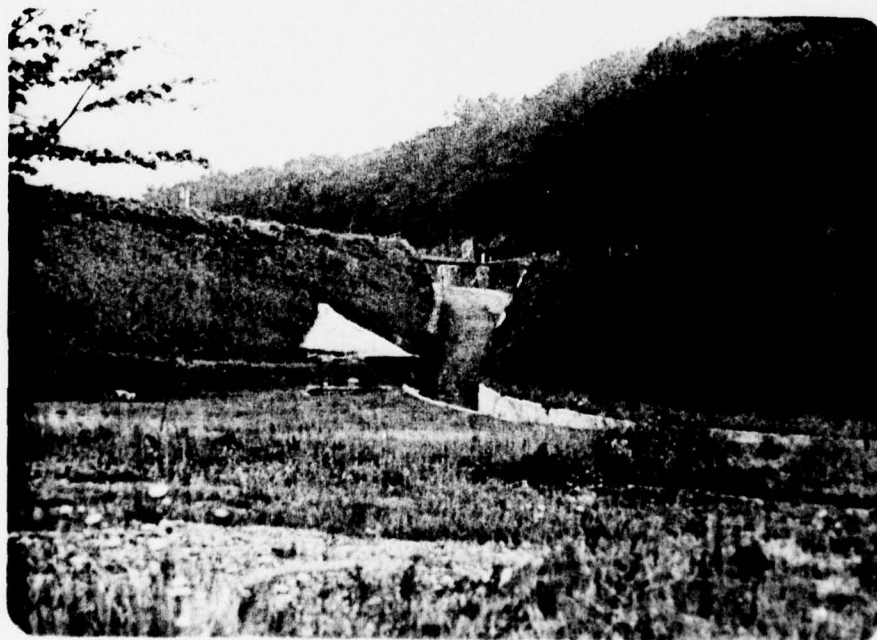
Photograph No. 2
Spillway chute. (Note old valve house
foundation right of spillway.)

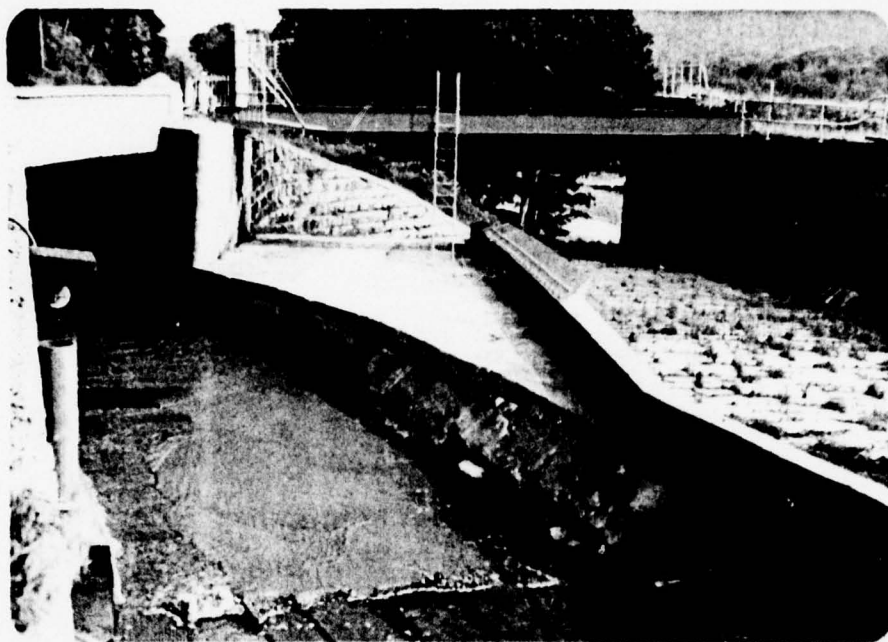
Photograph No. 3

Spillway crest. Reservoir spillway discharge channel (right), diversion overflow (middle), diversion tunnel entrance (left).

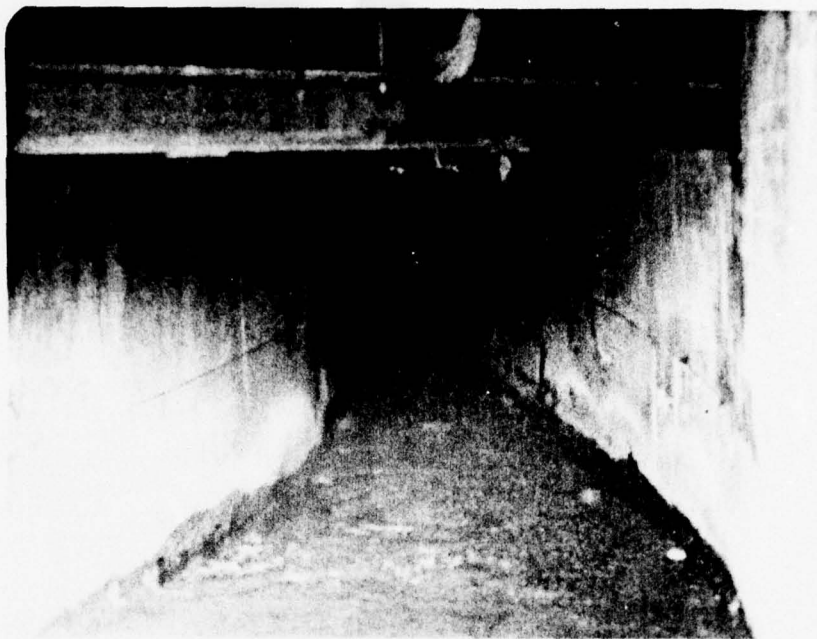
Photograph No. 5
Diversion tunnel.

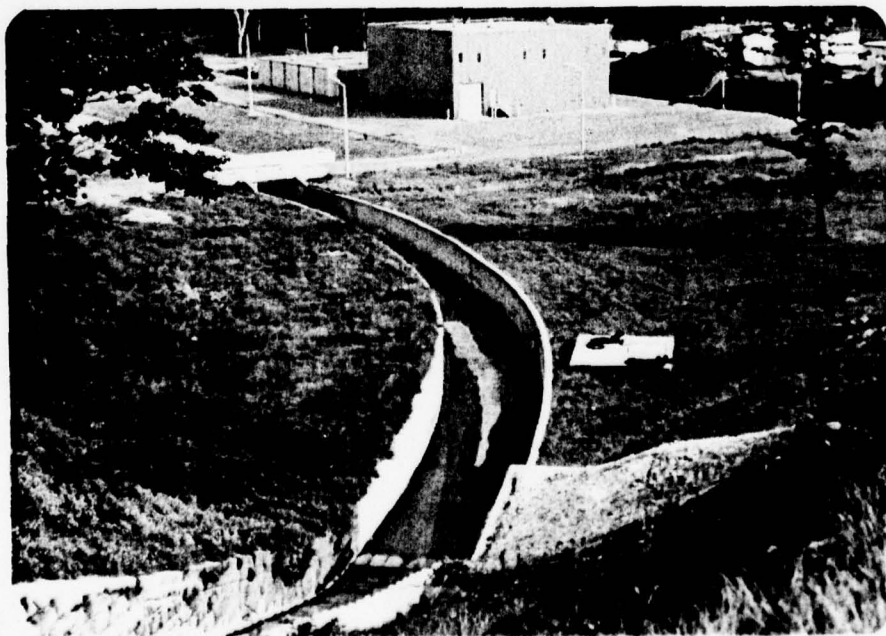
Photograph No. 6
Spillway discharge channel (blow-off pipe
valve chamber right of channel).

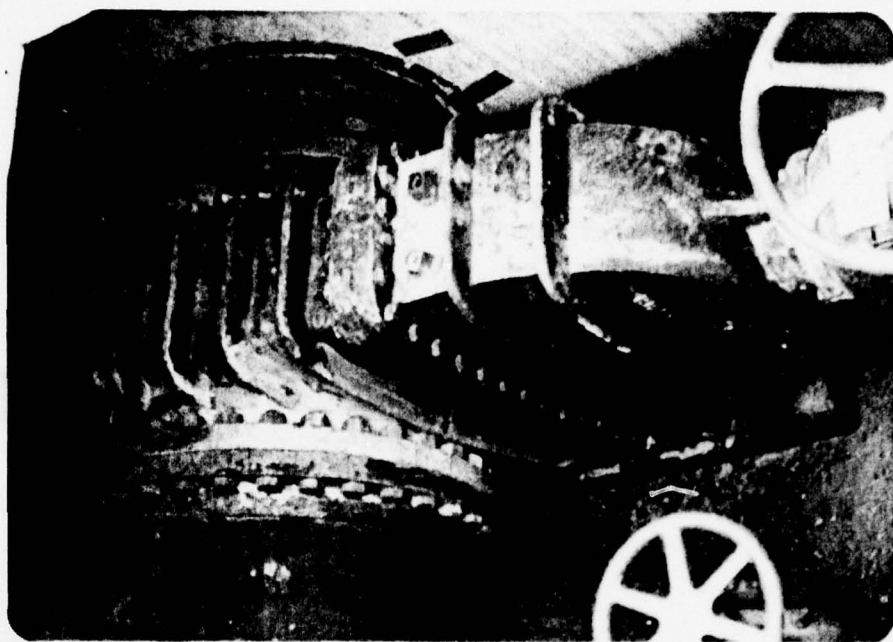
The downstream blow-off valve was operated by the city personnel and found to be functional.

4.3 Maintenance of Operating Facilities. The blow-off valve located at the downstream valve chamber was operated by the city personnel and observed to be functional. Visual observations indicate that the operating equipment is in good condition.

Photograph No. 7
Blow-off pipe valve.

4.5 Evaluation. The operational condition of the dam is considered to be good. However, it is considered advisable to develop a means of blocking the upstream end of the blow-off pipe in the event it is required to repair the pipe.

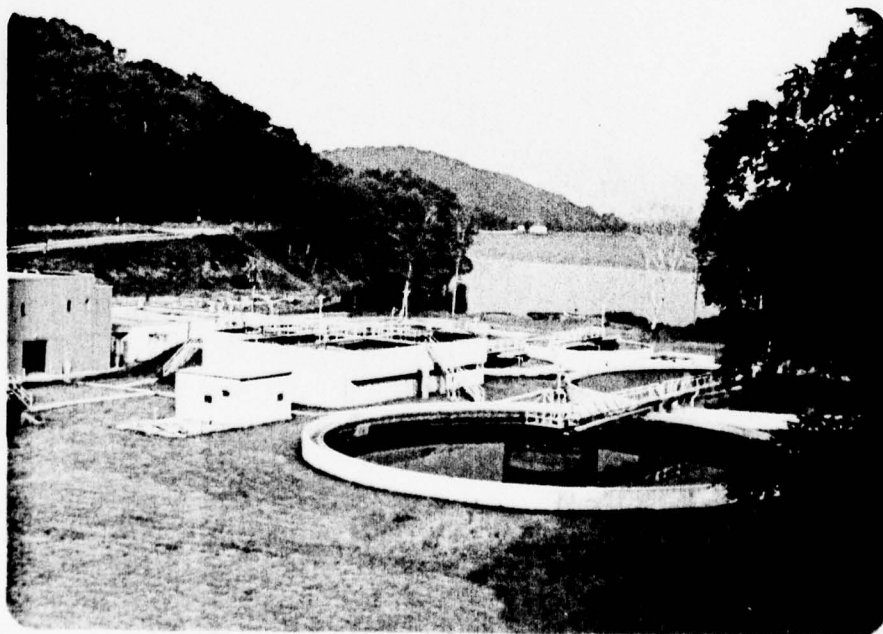
Photograph No. 8
Downstream: water treatment plant in foreground,
Lake Altoona Dam in background.

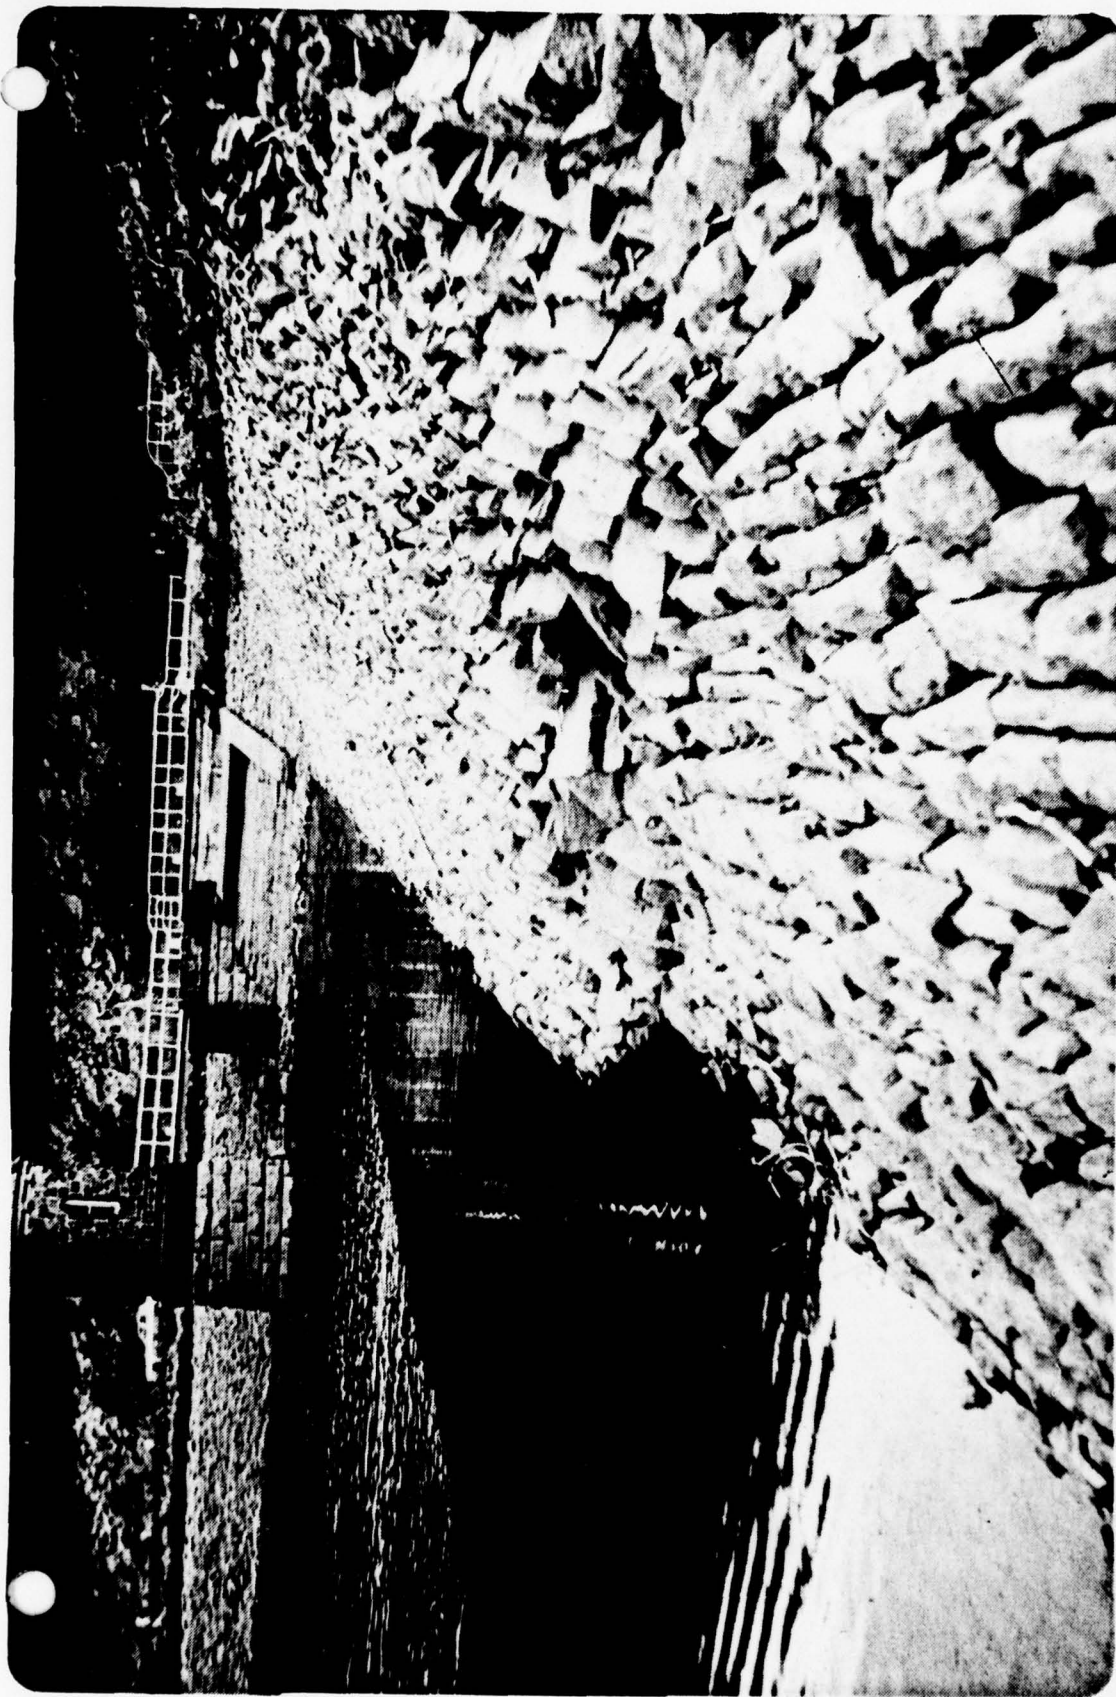
Photograph No. 9
Depression on upstream face.

A depression observed on the upstream face of the dam about 300 feet from the spillway is considered to represent a potentially hazardous condition which may threaten the integrity of the dam. However, the condition is not considered to be an imminent hazard because the lake level on the date of inspection was below the observed depression.

3.2 Evaluation. In view of the depression observed on the upstream slope which is considered to be a threat to the integrity of the dam, the condition of the dam is considered to be poor.

a. Assessment. In view of the depression observed on the upstream slope of the dam which is considered to be a potential threat to the integrity of the embankment, the condition of Lower Kittanning Dam is assessed to be poor.

1. It is recommended that the effect of the depression on stability and seepage through the embankment should be investigated by a professional geotechnical engineer.

The lake level should be maintained at a level not higher than 15 feet below the crest of the dam until further investigation is undertaken and appropriate repairs completed.

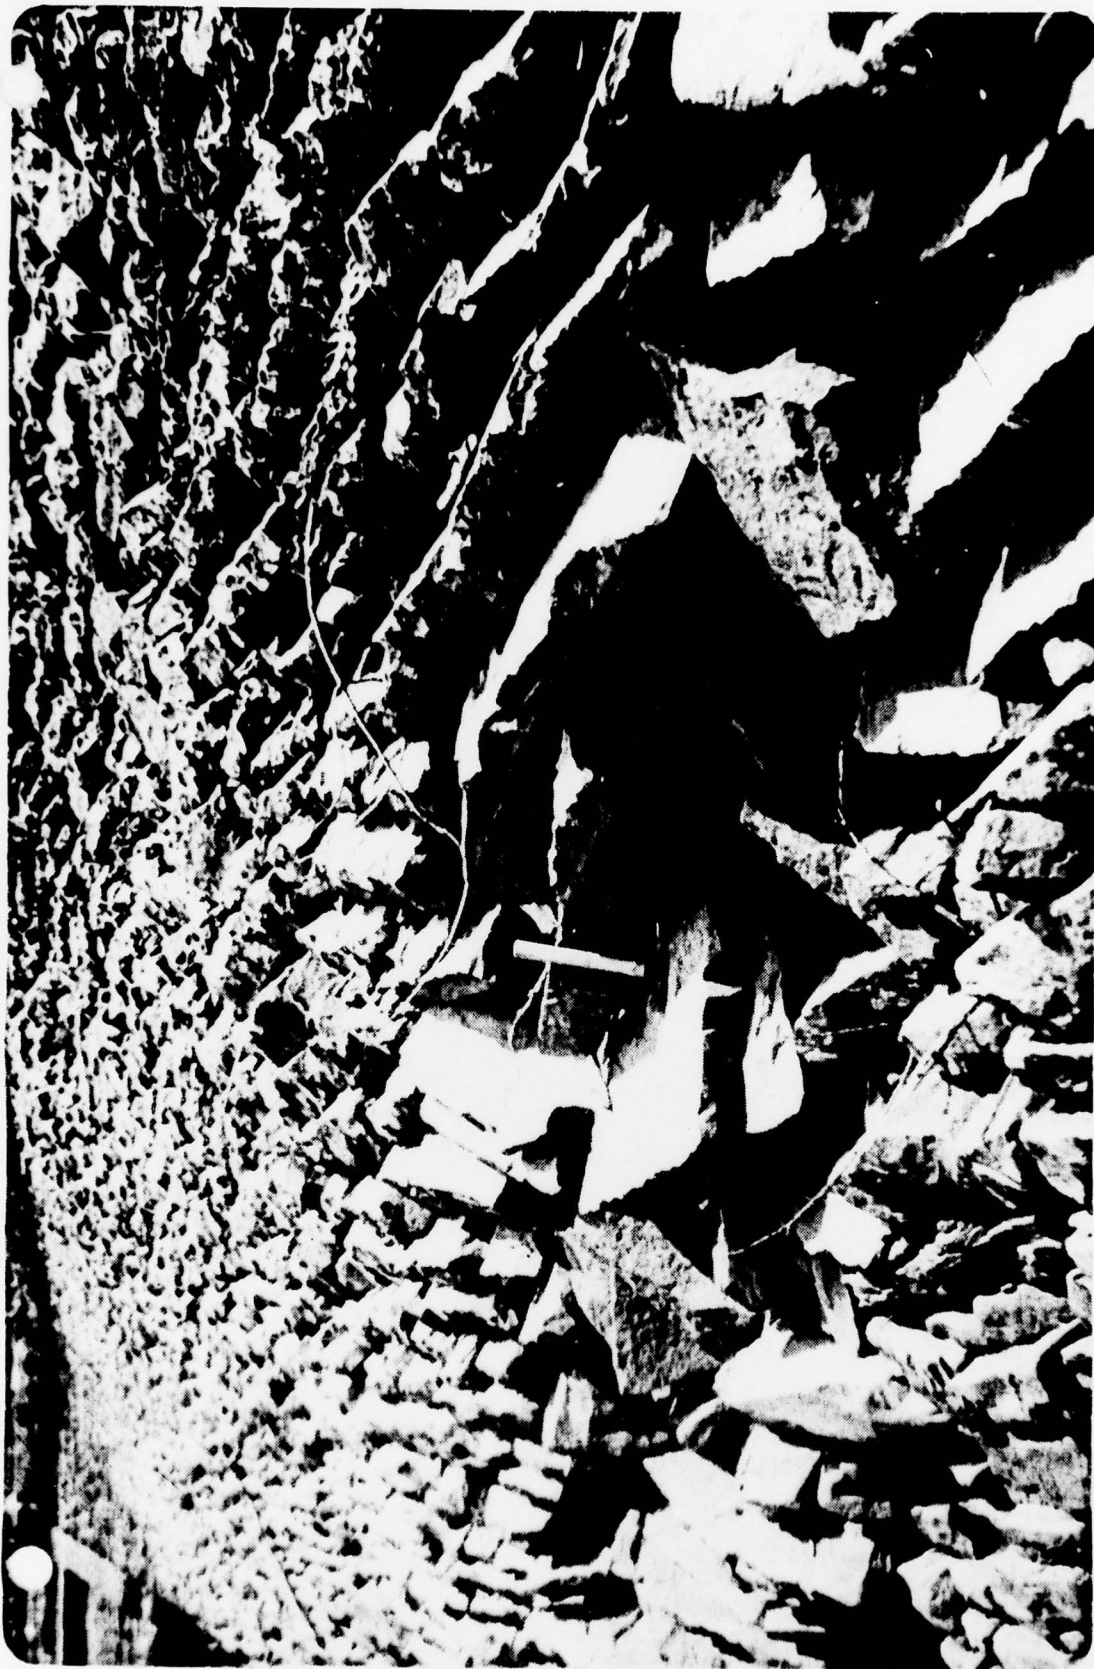
Photograph No. 10

Depression on upstream face (closeup).
